A Short Guide to Osmosis & its Treatment

Written by Nigel Clegg

Includes Suggested Moisture Readings and Painting Specifications, and an introduction to the HotVac system.

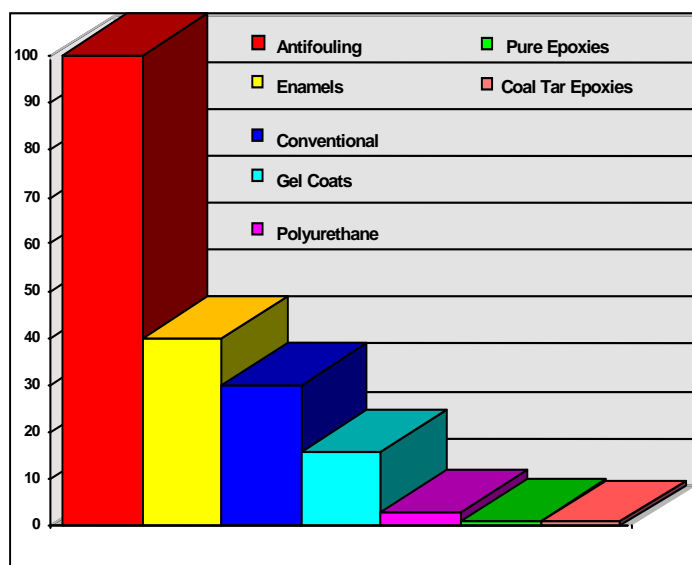
Fig 2. Chart Showing Comparative Moisture Permeability of Yacht Coatings

To answer the second question first, *all* organic paint coatings are capable of transmitting small quantities of moisture at molecular level owing to the tiny gaps or ‘holes’ in their molecular framework. Densely cross linked coatings like epoxies and two pack polyurethanes exhibit the lowest moisture permeabilities, while ‘loosely cross linked’ polymers such as those used in conventional alkyd paints are very much more permeable, and provide only minimal protection for GRP hulls.

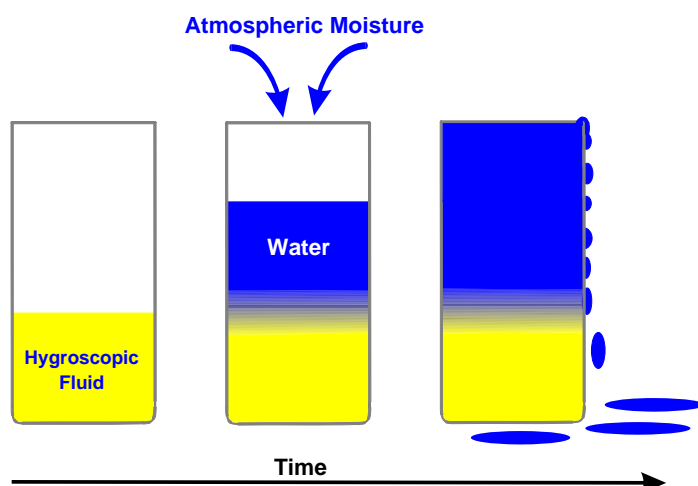
Fig 3. Diagram illustrating the moisture absorbent properties of hygroscopic fluids

hygroscopic,¹ and has a boiling point of around 188 °C - or nearly twice that of water. And like all alcohols, propylene glycol is 'polar'; which means that it is readily soluble in water; and once in solution will conduct electricity; so we should be able to find it with a good moisture meter.

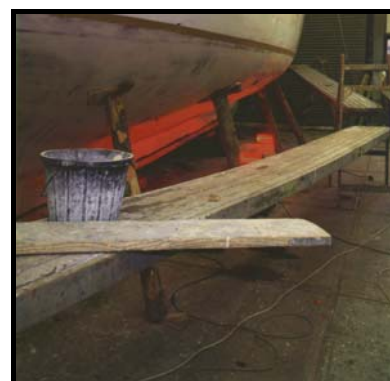
Fig 4. Infra Red heaters and Dehumidifiers do little to help cure osmosis

Sadly, the most widely accepted answer to this problem is to 'dry the hull out' with infra red heaters and a dehumidifier, after which the hull is quickly painted with an epoxy coating scheme "before the water can get back in again"!

Unfortunately this rather simplistic approach to high moisture meter readings usually causes more problems than to solves; for whilst a correctly applied epoxy may *slow down* the rate of moisture ingress, its densely cross-linked polymers will also prevent the escape of hygroscopic solutes - which means that blistering is even more likely to occur than if the gelcoat was left unprotected!

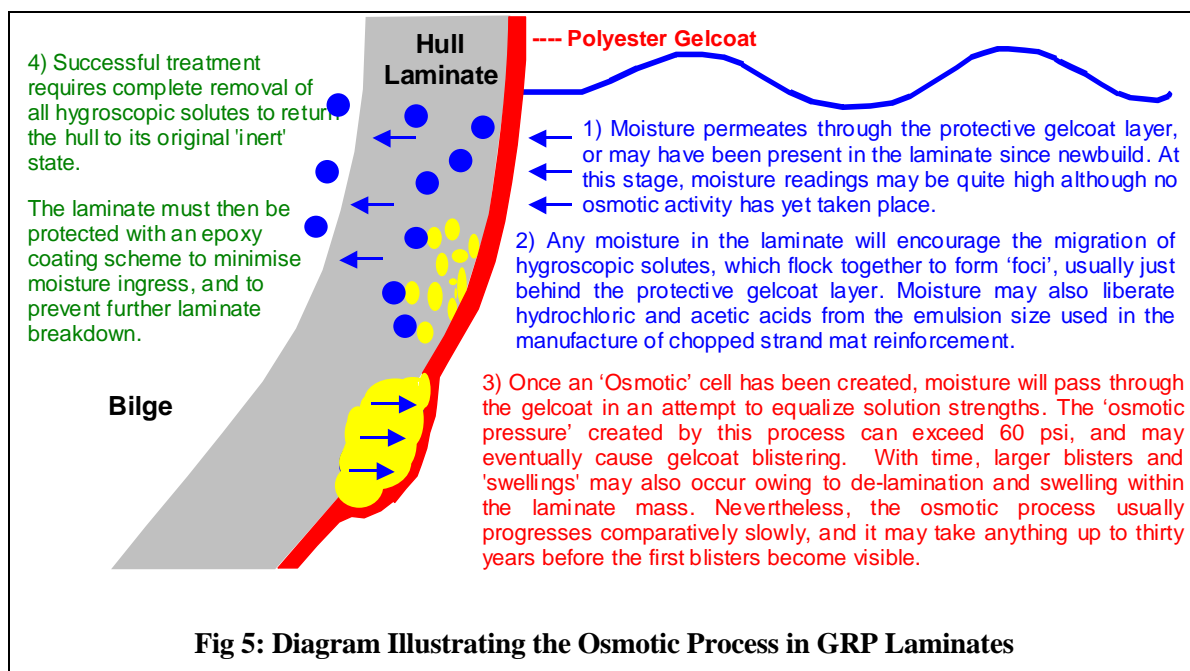
The diagram below shows how this process evolves:-

So to sum up, in *practical* terms, osmosis is probably best defined as “migration of hygroscopic solutes within a laminate owing to moisture ingress, which *ultimately* results in blistering of the gelcoat”.

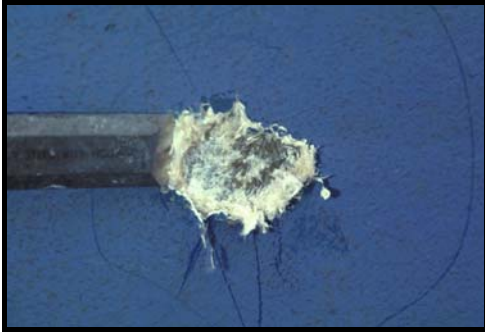
Fig 6. Removing a Section of Gelcoat with a Wood Chisel to allow inspection of the Laminate

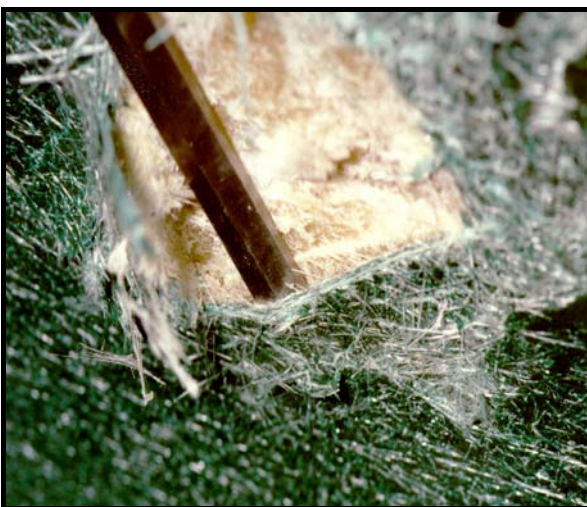
Fig 8. This poorly consolidated laminate had very little adhesion between layers of reinforcement, and was suffering from loss of mechanical strength.

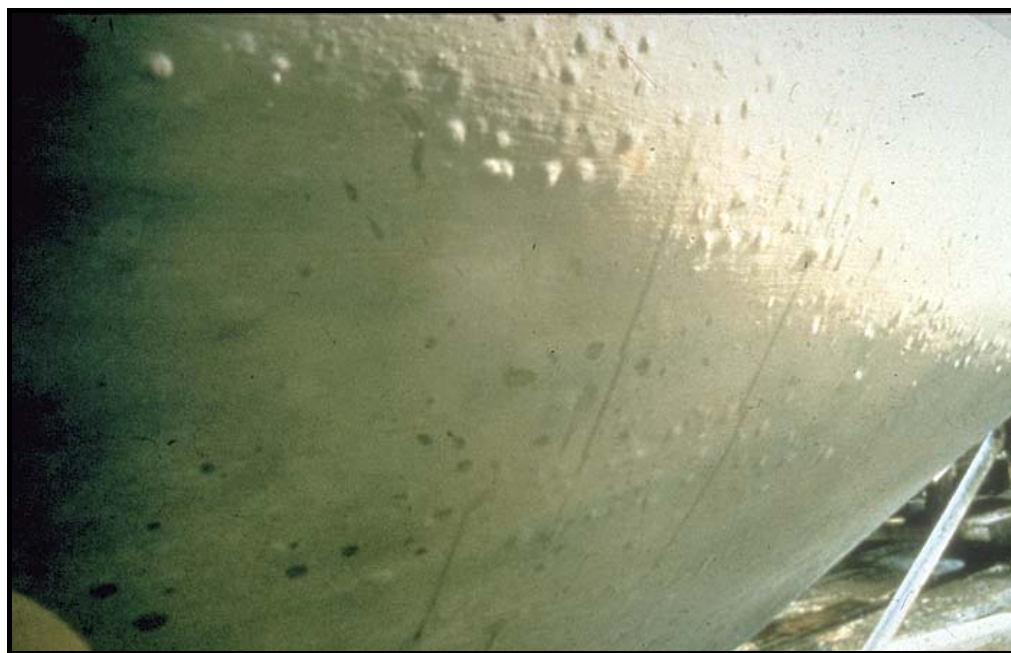
Fig 9. Blistering like this takes many years to develop, and will not be cured by any amount of heating or de-humidification. The HotVac system has proved very successful for treating ‘problem’ boats, but peeling, blasting and thorough fresh water washing remains an essential part of the process.

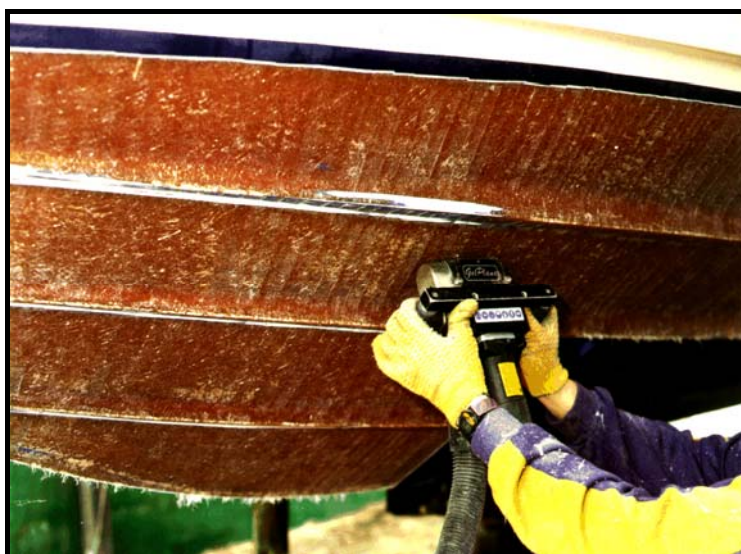
Fig 11. Gelcoat Peelers are ideal for bulk gelcoat removal, but note the very 'woolly' surface and unbound fibre left behind.

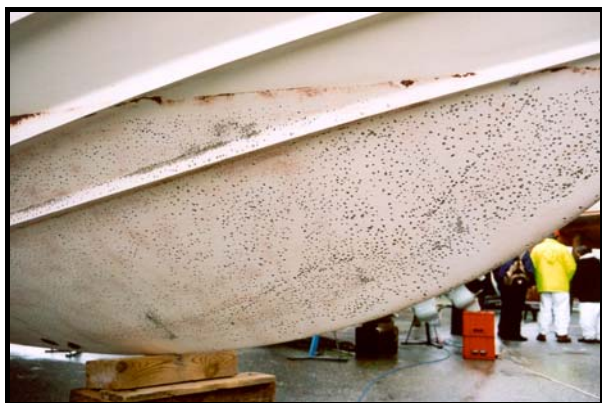
Fig 12. A poorly prepared laminate.

Note that little or no gelcoat has been removed from this hull, making removal of hygroscopic solutes next to impossible.

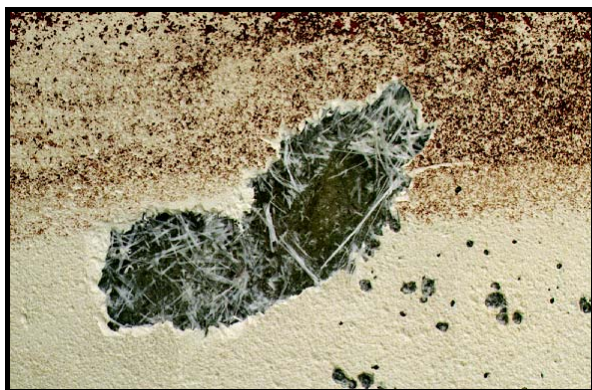
Fig 14. Unbound fibre behind a yacht's gelcoat.

Unbound fibre like this tends to harbour solutes, and will make successful treatment difficult.

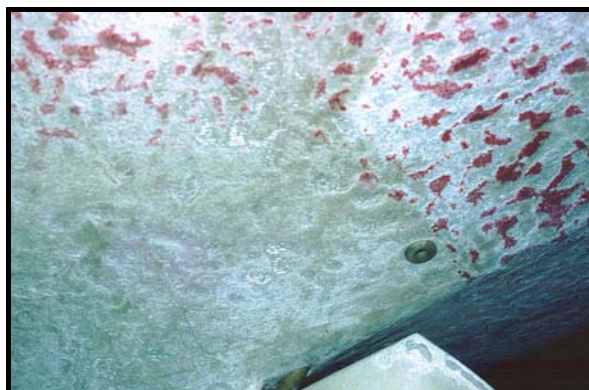
Fig 15. A well prepared laminate.

Note that nearly all gelcoat and unbound fibre has been removed from this hull.

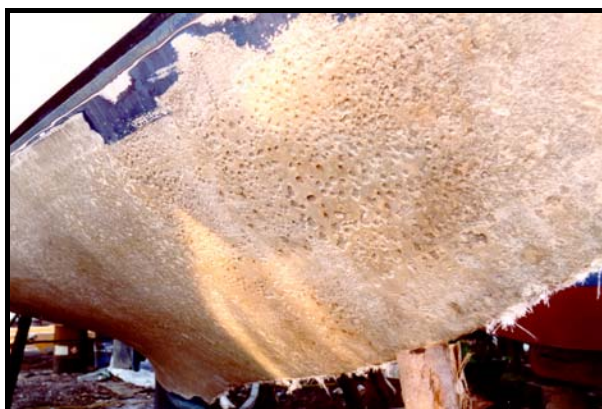
Fig 16 (left) and Fig 17 (right). These photographs show examples of good laminate preparation, with most or all of the gelcoat removed, and no loose or poorly consolidated reinforcement visible. Preparation to these standards will usually require extensive filling and fairing, but the treatment will be much more reliable as a result. Please note that the pock marks seen in **Fig 16** above were caused by air inclusions (introduced at newbuild), and not by osmosis!

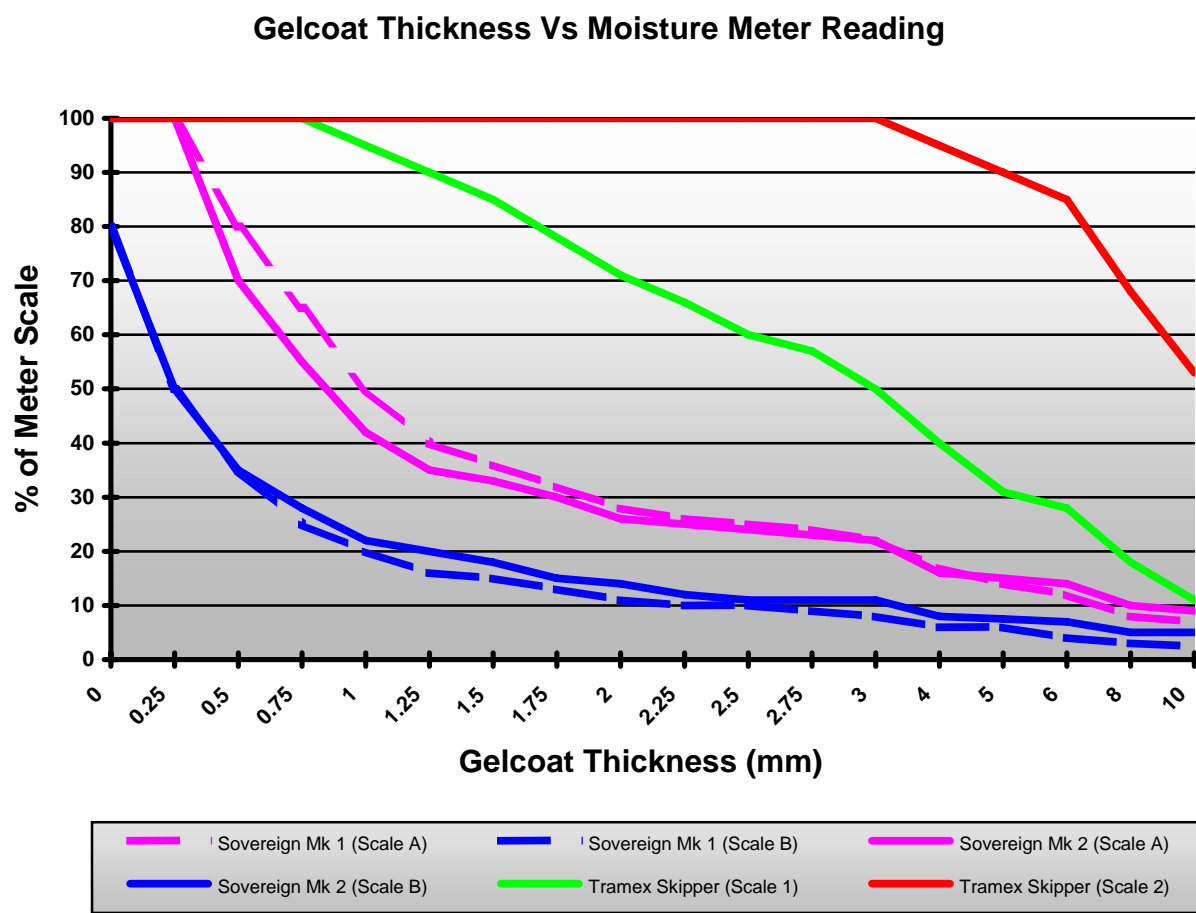
Fig 20. Graph Showing Moisture Meter Response relative to Gelcoat Thickness

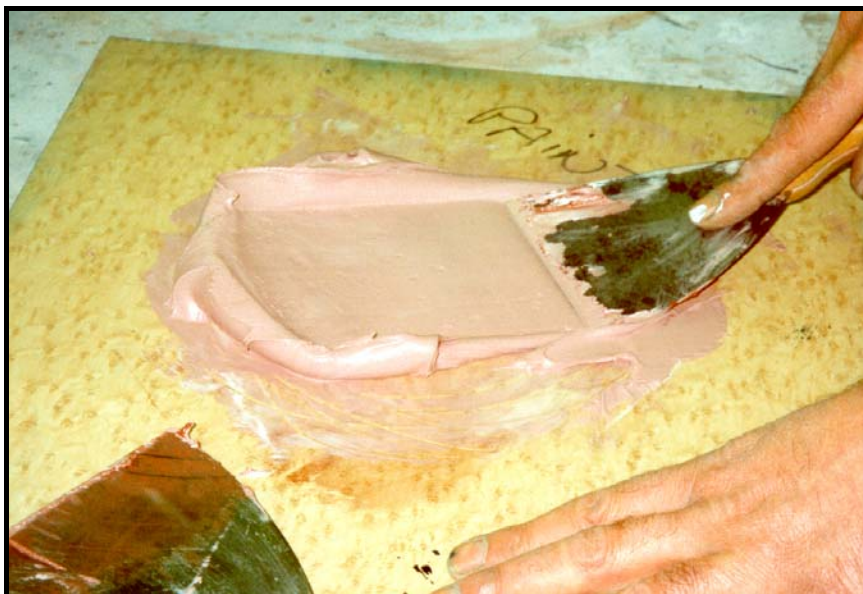
Fig 22. Epoxy fillers must be mixed thoroughly to ensure complete incorporation of the two components. Protective gloves should always be worn whenever mixing or applying epoxy materials!

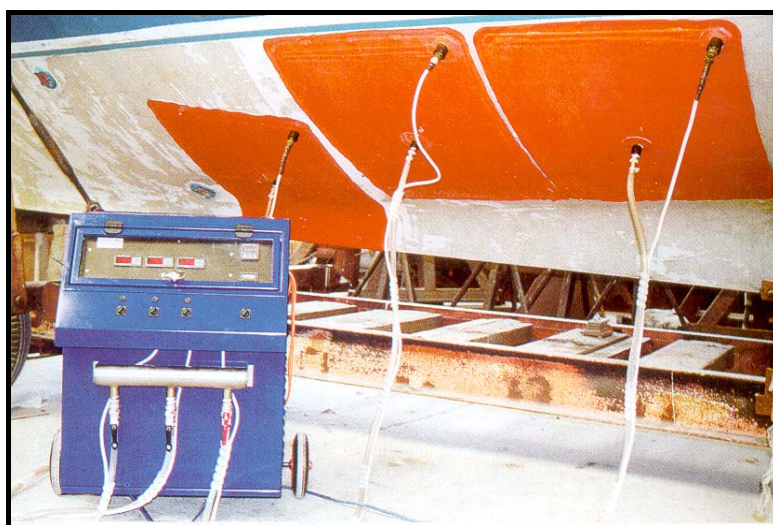
Fig 27. The Terry Davey “HotVac” system in use on a large GRP patrol boat at Fox’s of Ipswich.

Each **HotVac** system can run up to four blankets at a time, and these are applied in sequence around the yacht's underwater area until it is completely dried. Alternatively, the blankets can be applied to selected areas as required, or used for localised repairs.

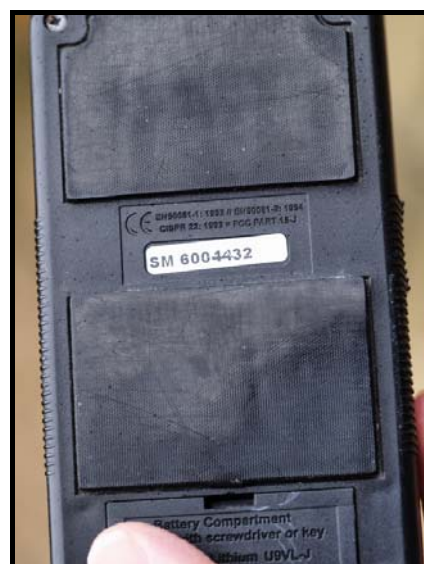
Worn electrodes like these will reduce sensitivity.

However, with constant use, the soft rubber electrodes on Tramex meters eventually lose their fine surface pattern, becoming worn and shiny like those in the picture below. This will noticeably reduce the instruments sensitivity to moisture. Similarly, the coaxial cables on older Sovereign meters can fail, whilst the scanning heads themselves will become worn. And of course meters can easily be damaged whilst in use, or even dropped into the water!
